## Strength test of Adjustable Safety Feet

On behalf of Telesteps AB, RISE has performed strength test on one type of adjustable safety feet for ladders.

Designation: Adjustable Safety Feet

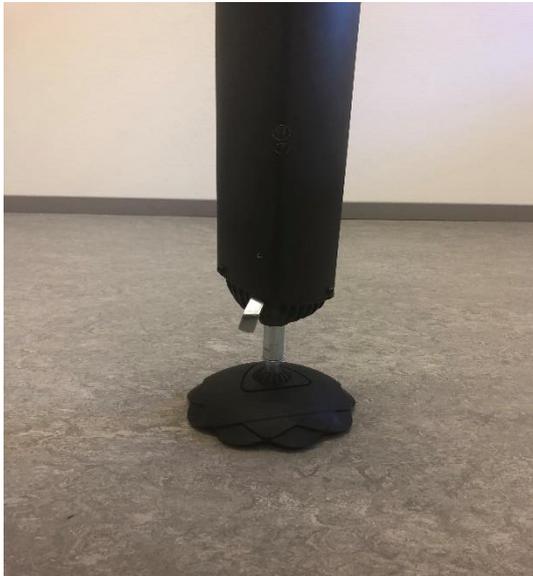
Figure 1 – Picture of tested object

Description: Adjustable safety feet for ladder made of aluminium.

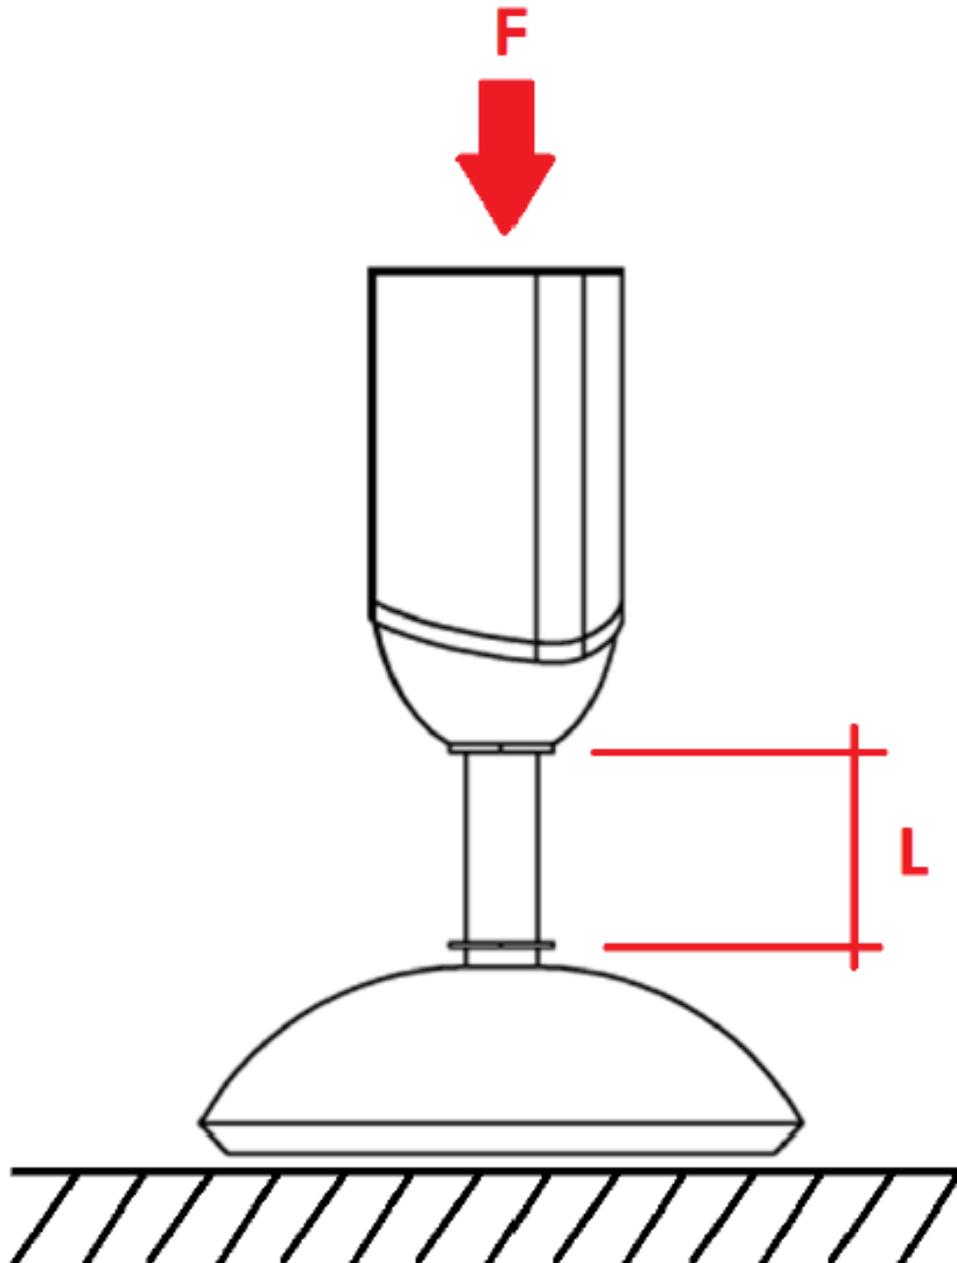
The test object was placed in a rig freely on the floor. Between the test object and hydraulic piston a 4 x 100 x 100 mm plate was used to distribute the load over the stile connected to the feet. The foot was extended so that L in the figure in Appendix 1 is equal to 50 mm out of a maximum 220 mm during loading.

1 Drawing of test setup (1 page)

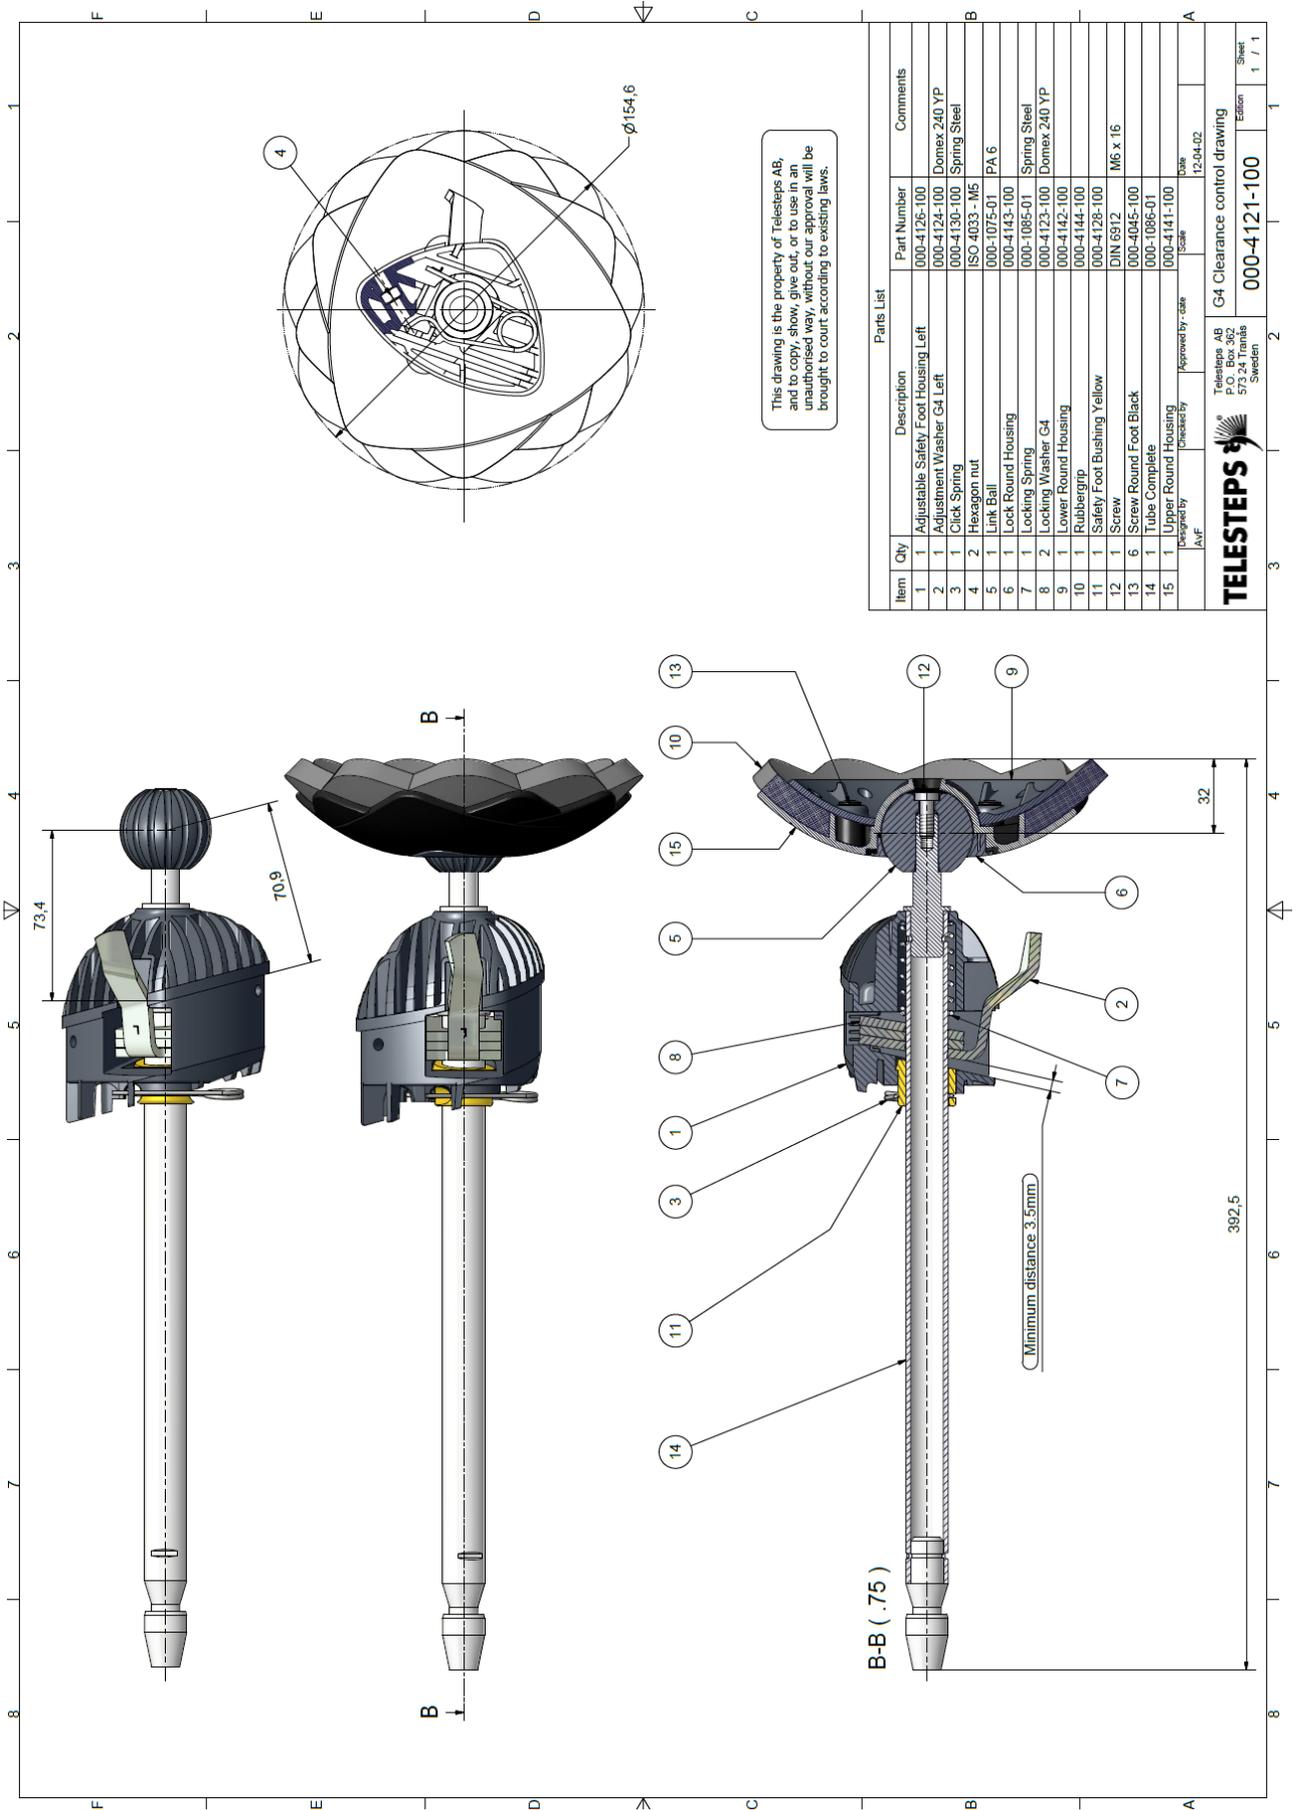
### Appendix 2

2 Drawing of the test object (1 page)
